HACKBRIDGE

PROJECT SUMMARY

Project Name:	Wandle River Restoration Project: Hackbridge
Location:	River Wandle, Hackbridge
Project Duration:	Sept 2012 – ongoing
Cost:	Approx. £150,000
Supported By:	Defra (Catchment Restoration Fund) Environment Agency, Living Wandle Landscape Partnership, London Borough of Sutton, Rydon Construction
Related Projects:	Butter Hill Phase 3

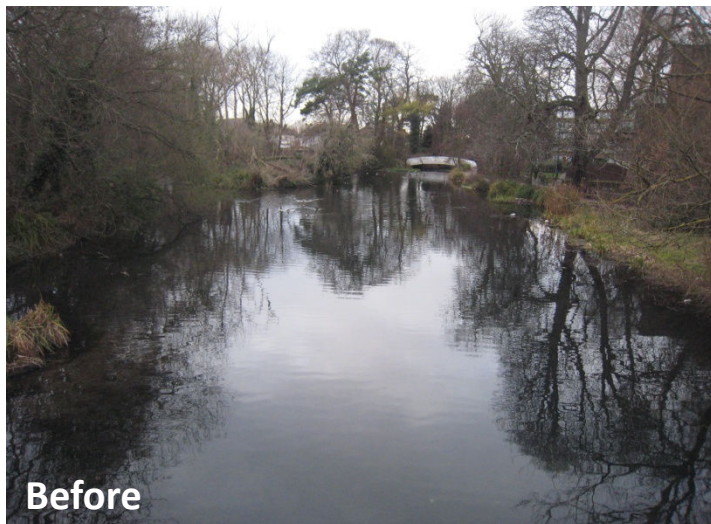
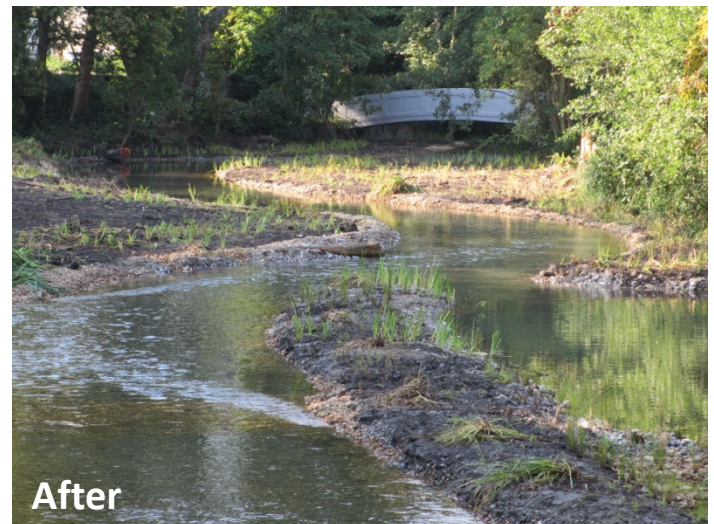
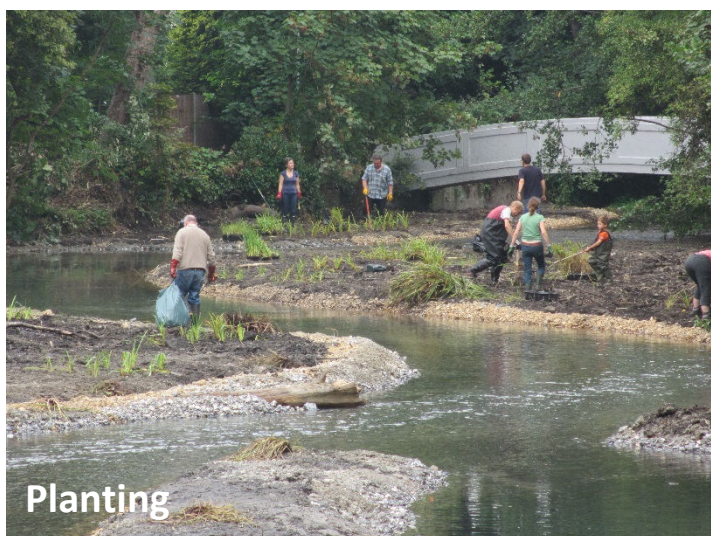
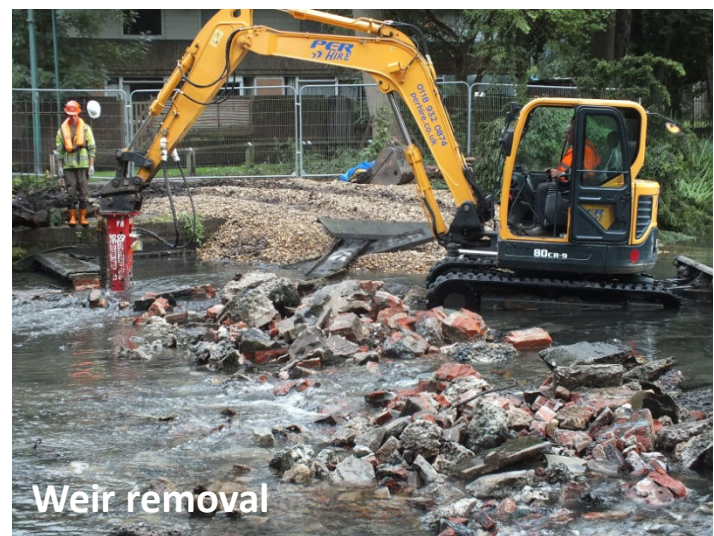
The work started with the removal of old toe-boarding from around the edge of Culvers Island. The island was re-profiled with a new bank line created using hazel faggot bundles secured with chestnut stakes and backed with coir netting. Sediment from the channel was then placed behind the new bank line.

The weir structures either side of the island were removed and the river channel narrowed using a combination of chestnut posts and hazel faggot bundles or gabion stone.

A causeway was built to create a backwater pond area using coir geotextile layered over a bed of stone and weighed down with gravel and sediment and planted with aquatic plants. The new island banks were re-graded to create a gradually sloped bank to which a variety of aquatic vegetation was planted with a team of 60 volunteers over three days.

Variations in depth, width and the introduction of gravel, small boulders and Large Woody Debris have all provided a diversity of habitats and increased the flow diversity of the channel throughout the site.
