<u>Watermeads Weir Options Outline</u> <u>Fish Passage - River Wandle</u>

January 2018

Living Wandle Landscape Partnership

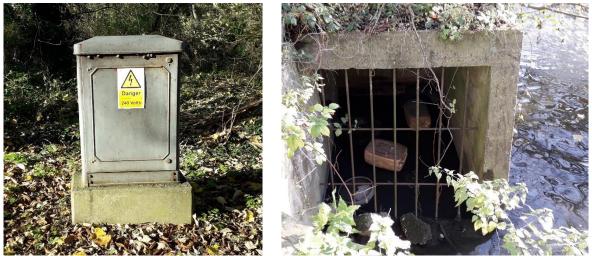
Figure 3. Photos of know utilities not highlighted by desk based utility search.

• Electricity - No records are marked on the UK Power Networks utility map. Although an electricity kiosk is present on the right bank, 15 m away from the weir (*Figure 3 - left*).

- Internet Records show a BT Openreach cable running from Riverside Drive to the weir.
- Water No records are marked on the Thames Water utility map, although a surface water outfall is present 25 m downstream of the weir structure (*Figure 3 right*). It is likely this conveys surface drainage from the Riverside Drive area.
- Gas No records are shown on the Scotia Gas Networks utility map.
- Others Linesearch indicates additional Gas providers within the site.

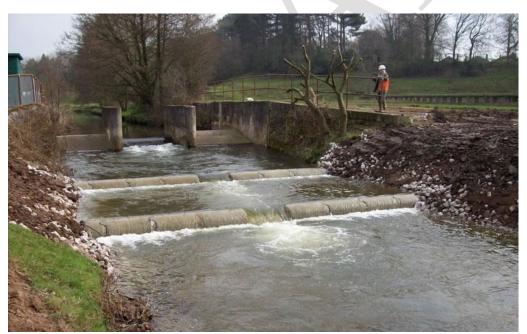
Figure 5: An example of a pre barrage used by Environment Agency to 'drown out' a weir - CT Construction Ltd.

A pre barrage structure similar to that shown in Figure 5 would need to be installed downstream of the weir in order to raise the tailwater level above the 0.4 m step which makes up part of the weir.

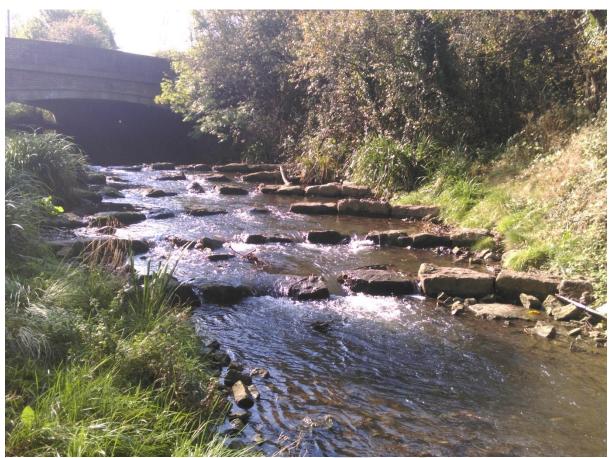
Figure 6. Rock ramp structure on the Hogsmill River near Kingston, London.

A large rock ramp structure similar to that shown in Figure 6 could be installed across the full width of the channel in order to maintain the water levels in the adjacent waterbodies. The preferred location would be directly downstream of the entrance to the Papermill Cut. Delivery this solution would enable over 250m of the channel to be unimpounded and restored.

In order to be passable to coarse fish, the ramp would be required to be c.30m in length (gradient 1:20). The logistics of bringing in such large amounts of material for the construction of a rock ramp at this site would be a challenge, likely requiring a temporary trackway.

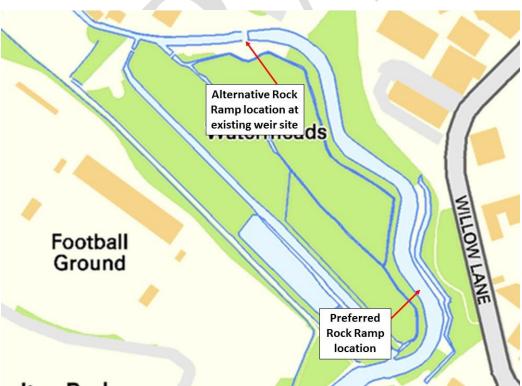
Figure 7: Potential locations for rock ramp.

More detailed investigations would be required to determine the potential hydraulic implications on the adjacent waterbodies if the rock ramp was installed anywhere upstream of the current weir location. Potential locations for a rock ramp are shown in Figure 7.

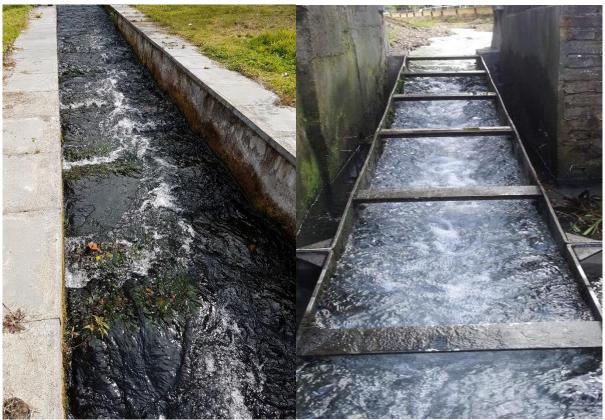
Figures 8 & 9. Examples of a Hassinger bristle pass (left) and a Larinier superactive baffle fish pass on the Wandle at Carshalton (right).

The overall slope and channel widths suggest a Hassinger Bristle pass (*Figure 8.*) would be the preferred option. With some minor modifications to the existing concrete structure (*Figure 10*), a series of bristle rows could be extended all the way through the structure.

If after further investigations the hydraulic considerations prevent its use, a Larinier pass (*Figure 9*) could be explored. This option would require a pre barrage to be installed at the downstream end and may also require resting pools within the structure. Although passage could be achieved with a Larinier it is less desirable because it would not function for smaller fish species.
