Canada Goose Management in the Wandle Valley

This report identifies the issues faced in the Wandle Valley due to the Canada goose population. It aims to identify current population distribution, management controls in place and techniques that can be implemented to reduce Canada goose numbers.

Living Wandle Landscape
Partnership Scheme

August 2015

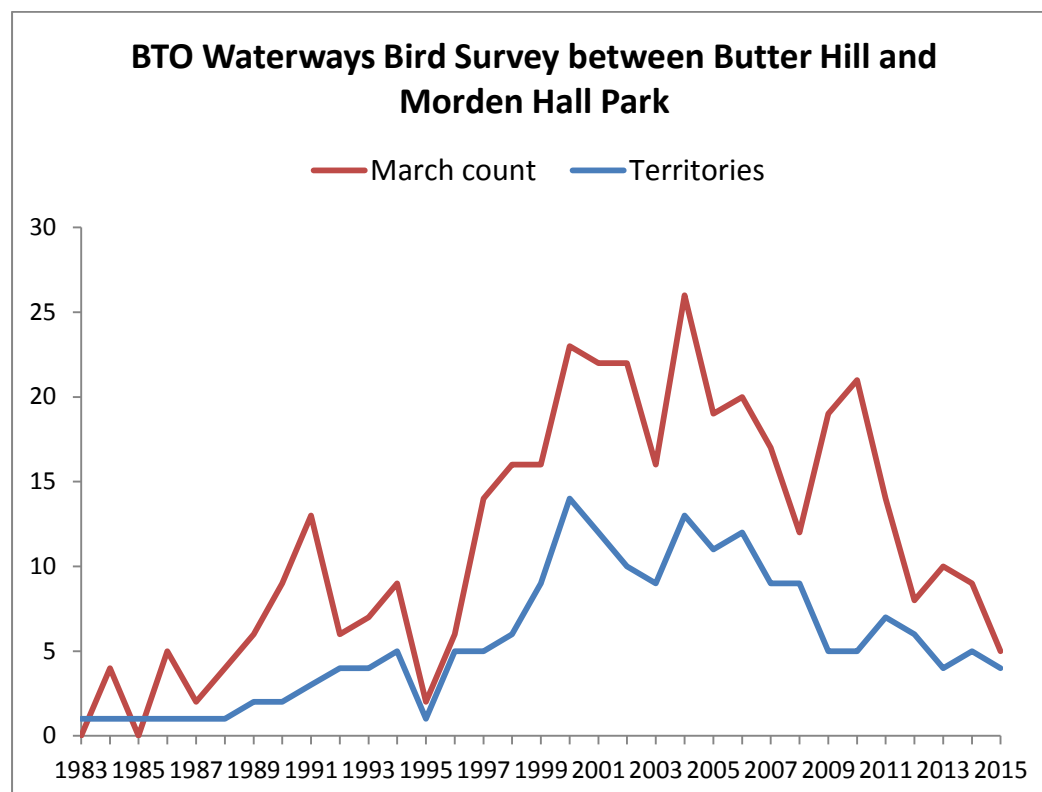
Figure 2: Graph showing the Canada geese numbers along the River Wandle (Coleman, 2015a)

Other data available from Coleman (2015a) covers the Wandle from Butter Hill Bridge, Carshalton to the tramline at Morden Hall Park (Coleman, 2015a) shown in Figure 2. In 2001, there was no count. This data represents observations along the Wandle and does not include full surveys for all the associated green spaces along the surveyed stretch. A moult count on the Wandle this year produced 73 birds (excludes juveniles).

In the upper Wandle, geese are known to breed along the river but the main breeding sites are Beddington Farmlands and Mitcham Common and without these two sites, it is unclear as to whether the population would be self-sustaining. The creation of islands on the lakes at Beddington Farmlands in 2000 and 2009 led to an increase in the number of pairs breeding, the islands on the ponds on Mitcham Common also provide suitable breeding habitat. The number of young produced from these two sites account for the majority of the birds seen on the upper Wandle. Canada geese do breed on the river but never produce such high numbers of young.

The number of Canada geese is recorded by territories, the definition used when a bird is seen at least three times at the 'same place' during a survey of seven or more visits, it does not equate to breeding pairs (pairs present but not necessarily successful) with young (Coleman, 2015a).

These figures show that the populations and territories along the Wandle fluctuate between years and that there has even been a decrease since 2005. This is only a measure between Butterhill and Morden Hall Park, Canada goose habits and territories could change year on year. The number of territories (pairs present but not necessarily successful) on the river between Butter Hill, Carshalton and Morden Hall Park reached a peak of 14 in 2000, since then it has declined to four in 2014. Pairs also often attempt to breed at Carshalton Ponds, Beddington Park and Waddon Ponds.

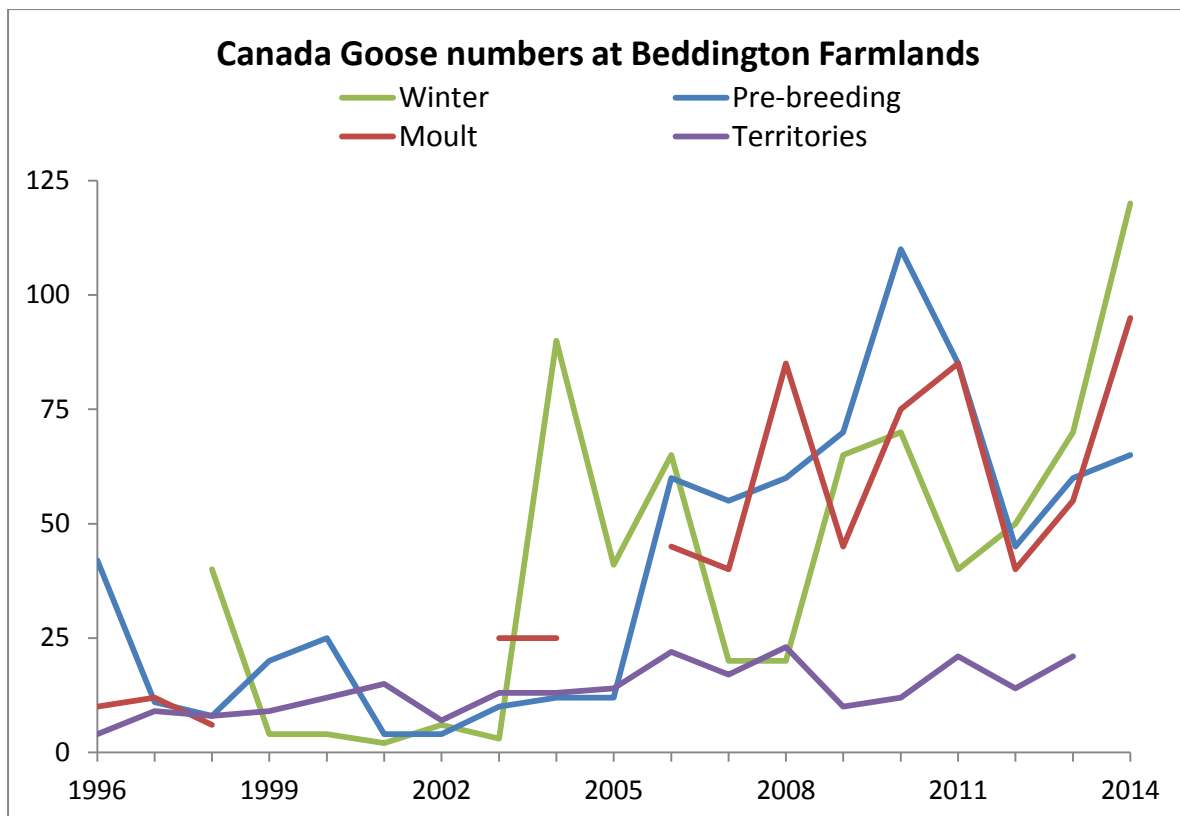
Figure 3: Graph showing Canada goose numbers at Beddington Farmlands (Alfrey *et al.*, 2015)

Figure 3 shows an increase in goose numbers most years, with some steep increases or declines. The population figures are much higher at Beddington Farmlands than the figures collected in the same year along the Wandle, between Carshalton and Morden Hall Park. Beddington Farmlands is an area not accessible by the public and therefore more appealing for geese as there is are fewer disturbances.

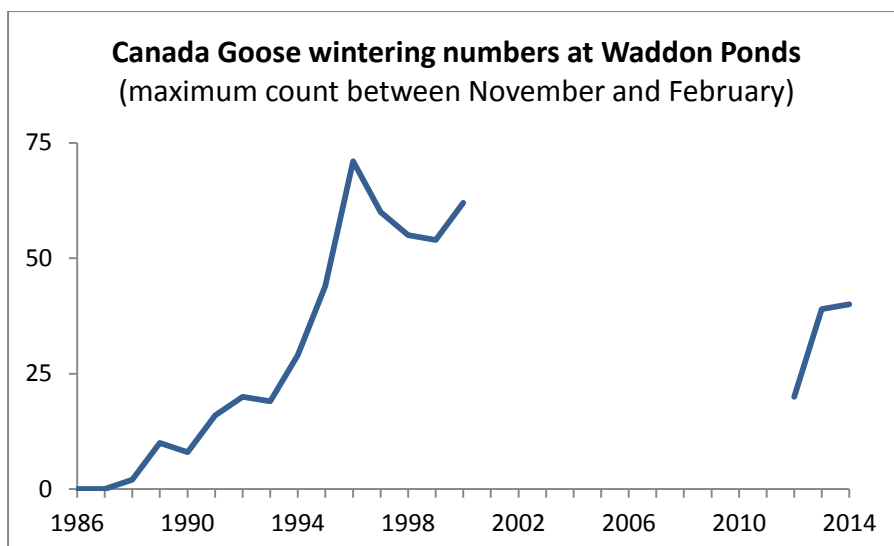
Figure 4: Graph showing the wintering Canada goose numbers (Individual) at Waddon Ponds – No count made in the period 2000 - 2012 (British Trust for Ornithology, 2015)

Observations from the Green Space Development Officer at Croydon council have identified one site within our featured area with a Canada goose population, Waddon Ponds. In the past, the ponds have suffered from a high volume of geese, in the region of up to 100 birds. Figure 4 (overleaf) highlights the high count of individual Canada geese present at Waddon Ponds during the winter months. Only a few geese are resident at the ponds, but this can result in up to 15 goslings per breeding season. In June 2015 a nest, the eggs and the female were destroyed, the circumstances of the attack are unknown, but it could have been predation or human intervention. Other broods were been successful in 2015 at the ponds. Fouling is a large problem at Waddon ponds (also contributed to by the high volume of coots at the ponds, however numbers of Canada geese have declined from around 100 to 30 in recent years); over grazing by the geese is also an issue here. The poaching of the banks at the ponds has resulted in erosion of the bank structure by 2 – 3 metres. The ponds are spring fed and the flowing water carries any fouling residue through the weir. If the flow of the spring reduced it could result in the water level dropping, leaving stagnant water, fouling could then contribute towards problems such as blanket weed etc. Public feeding is a big issue at Waddon ponds, large amounts of bread are often left on the banks by local people and a local food vendor.

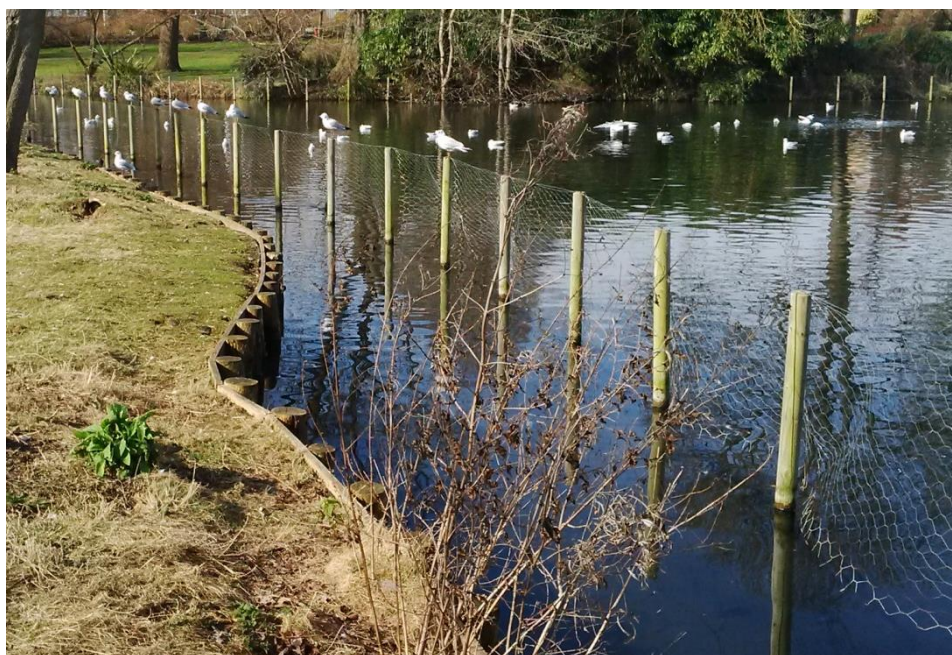
Figure 9: Fencing at Waddon Ponds used to break up the expanse of open water

Permanent: Canada geese dislike enclosed areas, it makes them more vulnerable to predators and restricts their ability to take off and land, by fencing an area it makes it less attractive to the geese. This deterrent method can protect sensitive areas and prevent bankside access by geese to bodies of water (Natural England, 2011a). This method can however cause problems for other wildfowl that the land manager may be trying to attract; therefore, it must be used sensitively. Croydon Borough Council has used fencing at Waddon Ponds (Figure 9) to break up open water and prevent bankside access. Permanent fencing can restrict public access as well as geese. Restricting public access can keep the public away from the waters edge and discourage feeding.

Temporary: Temporary fencing can be used to allow vegetation to establish in ponds or on banksides to prevent geese from damaging the planting. Once the vegetation is established the fencing can be removed; when installing fencing, the public must be kept informed of its purpose to prevent objection and potential damage to the fences.

The Council have installed fencing around new bankside vegetation at Waddon Ponds to protect it from the geese, this method has helped the vegetation to establish without disturbance. Croydon Council have a few posters at Waddon Ponds explaining about the impacts feeding the wildfowl bread has on both the birds and the water quality (See figure 8). Park users often remove the posters on display (Figure 8). A slight reduction in geese has been observed since the fencing and planting measures have been implemented.

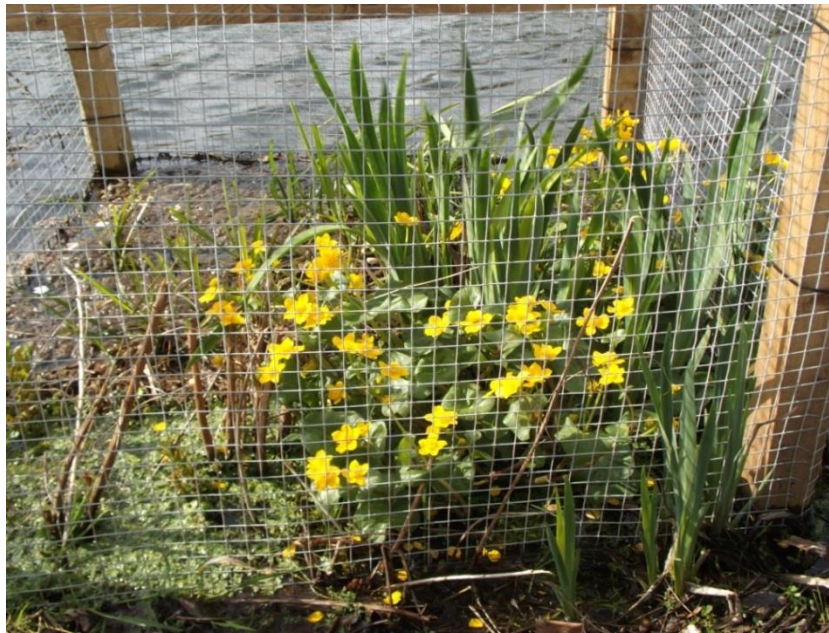
Figure 10: Marsh Marigold amongst other vegetation planted at Waddon Ponds, Croydon

Habitat Adjustment: Vegetation and bankside management are a natural way of discouraging geese from green spaces or open water. This is a natural method using vegetation to deter geese; it can reduce access to water bodies or bank edges. It creates natural barriers between areas and reduces the flight paths for Canada geese in and out of water bodies (Natural England, 2011a). Vegetating banksides can also reduce the public's direct access to the water, potentially reducing feeding (throwing food) directly into the water. This method is also practical for use on large expanses of grass, breaking areas up with borders or shrubs, restricting the view of open water/landing sites. Figure 10 & 11 demonstrates habitat adjustment that has taken place at Waddon Ponds, Croydon. Planting aims to reduce access to the pond and the vegetation can be temporarily fenced while it establishes.

Managing the grass and marginal vegetation differently can also help make an area less appealing for Canada geese. By leaving areas of grass longer or rotating mowing regimes the concentration of geese can be moved around, relieving areas of pressure. Changing marginal vegetation to robust species (that Canada geese do not favour) can help to reduce the available food source for the geese, the impact on other wildfowl must be considered if using this method. Table 2 indicates species suitable to deter geese (this is not an exclusive list). Preventing nesting and making areas less appealing is a good way to avoid allowing birds to nest.

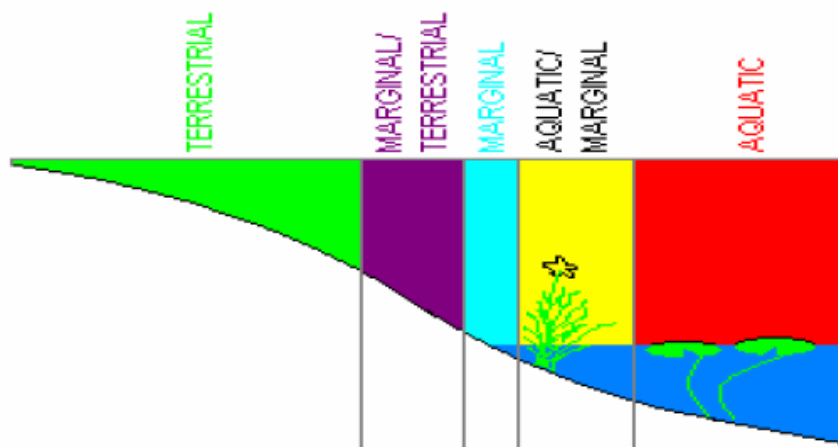
The plant species have been split into 5 different zones depending on where they naturally occur on the bank, these are shown below:
