DALE PARK - EXISTING

DALE PARK - PROPOSED

RESTMOR WAY
PROPOSED PLAN

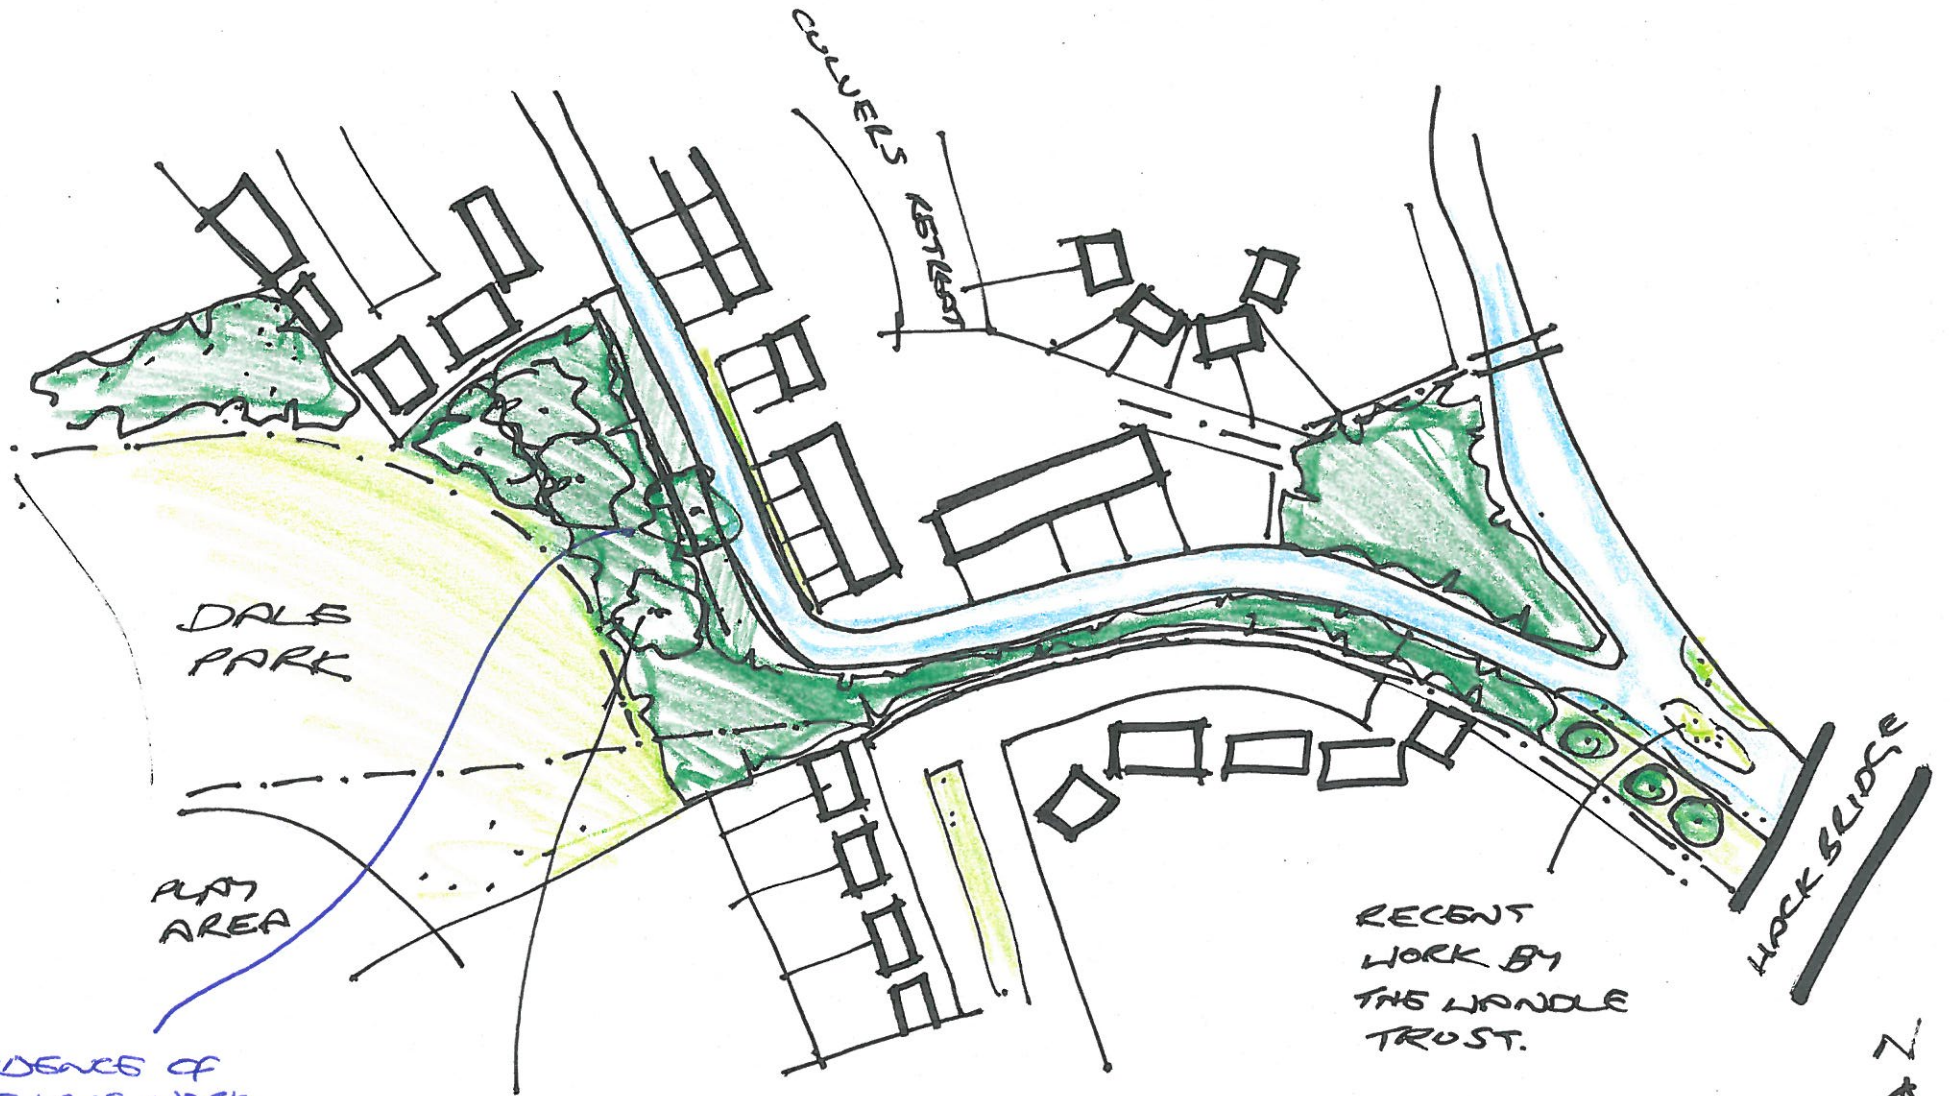
EVIDENCE OF
PREVIOUS LOCK
TO RIVERBANK SCRUB AND
AND INFORMATION MATURE TREES.
BOARD.

RECENT
WORK BY
THE HANDLE
TRUST.

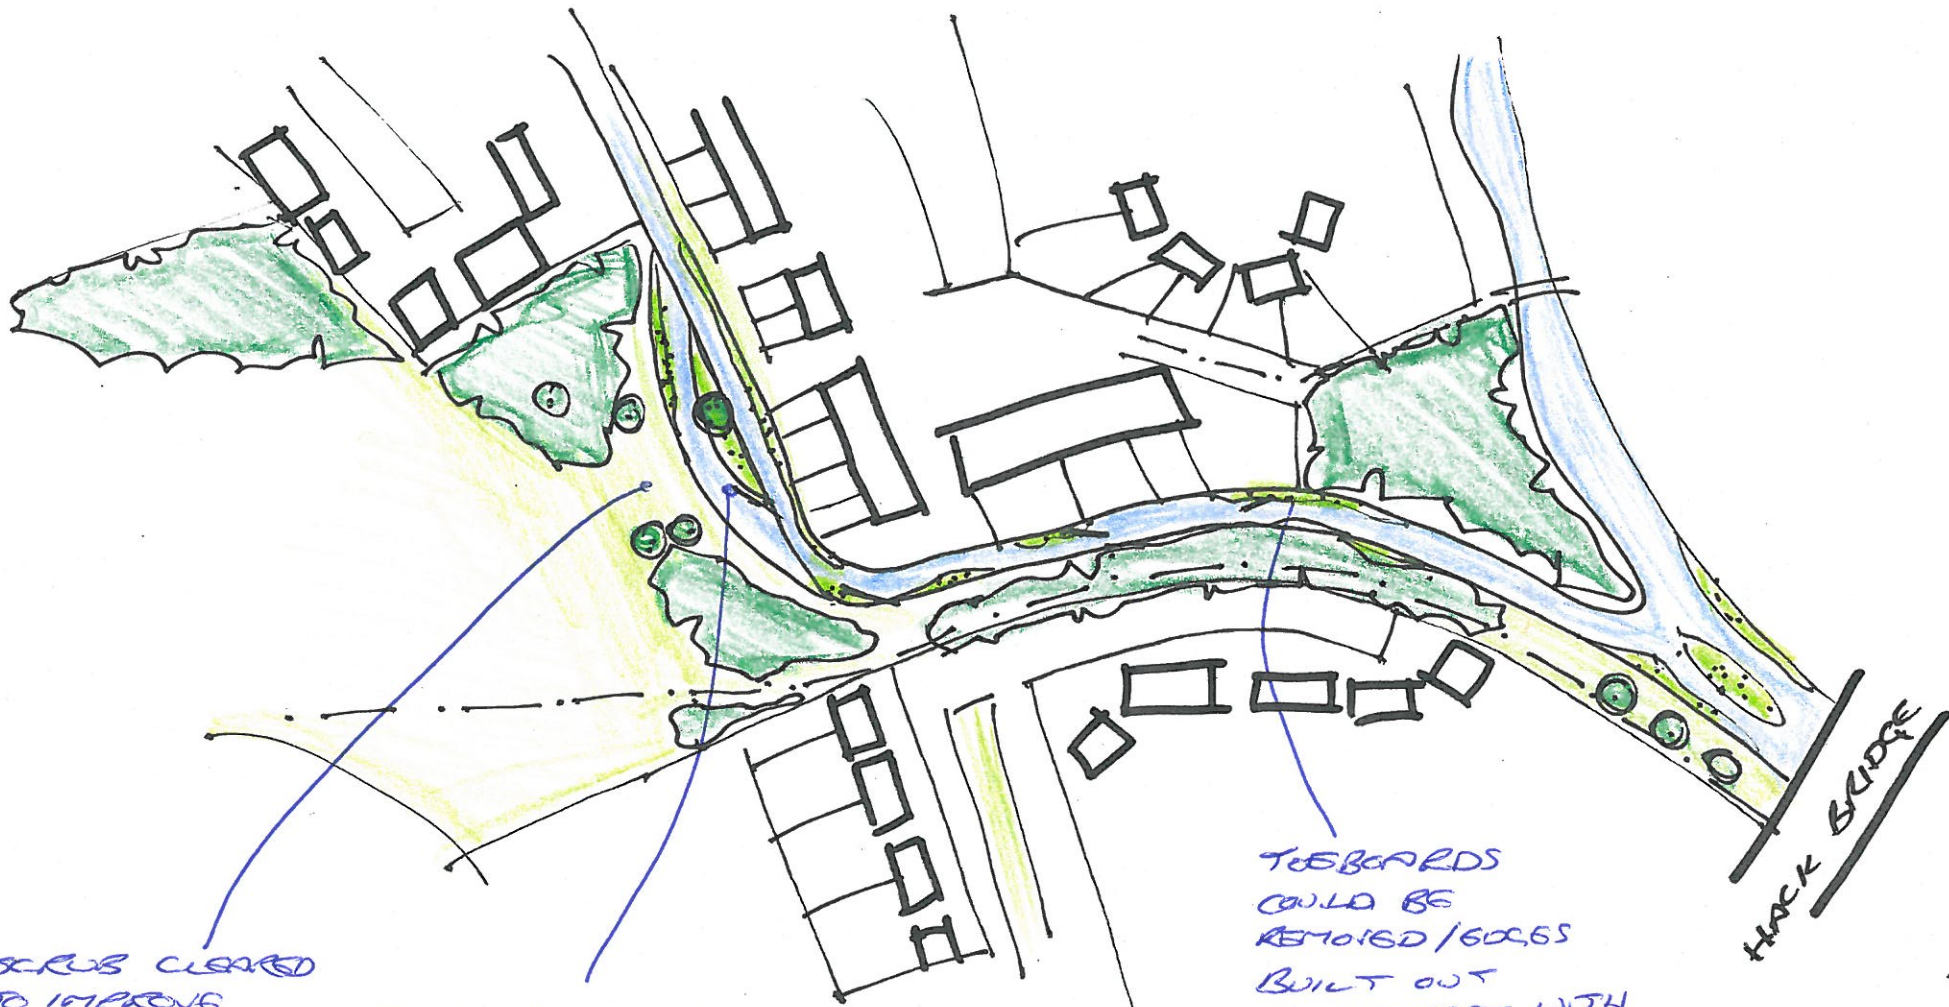
SCRUB CLEARED
TO IMPROVE
ACCESS

EXISTING TIERED
AREA USED TO
CREATE BACKWATER

TIEBOARDS
COULD BE
REMOVED / GOALS
BUILT OUT
TO CONNECT WITH
RECENT REHAB
PROJECT

HACK BRIDGE

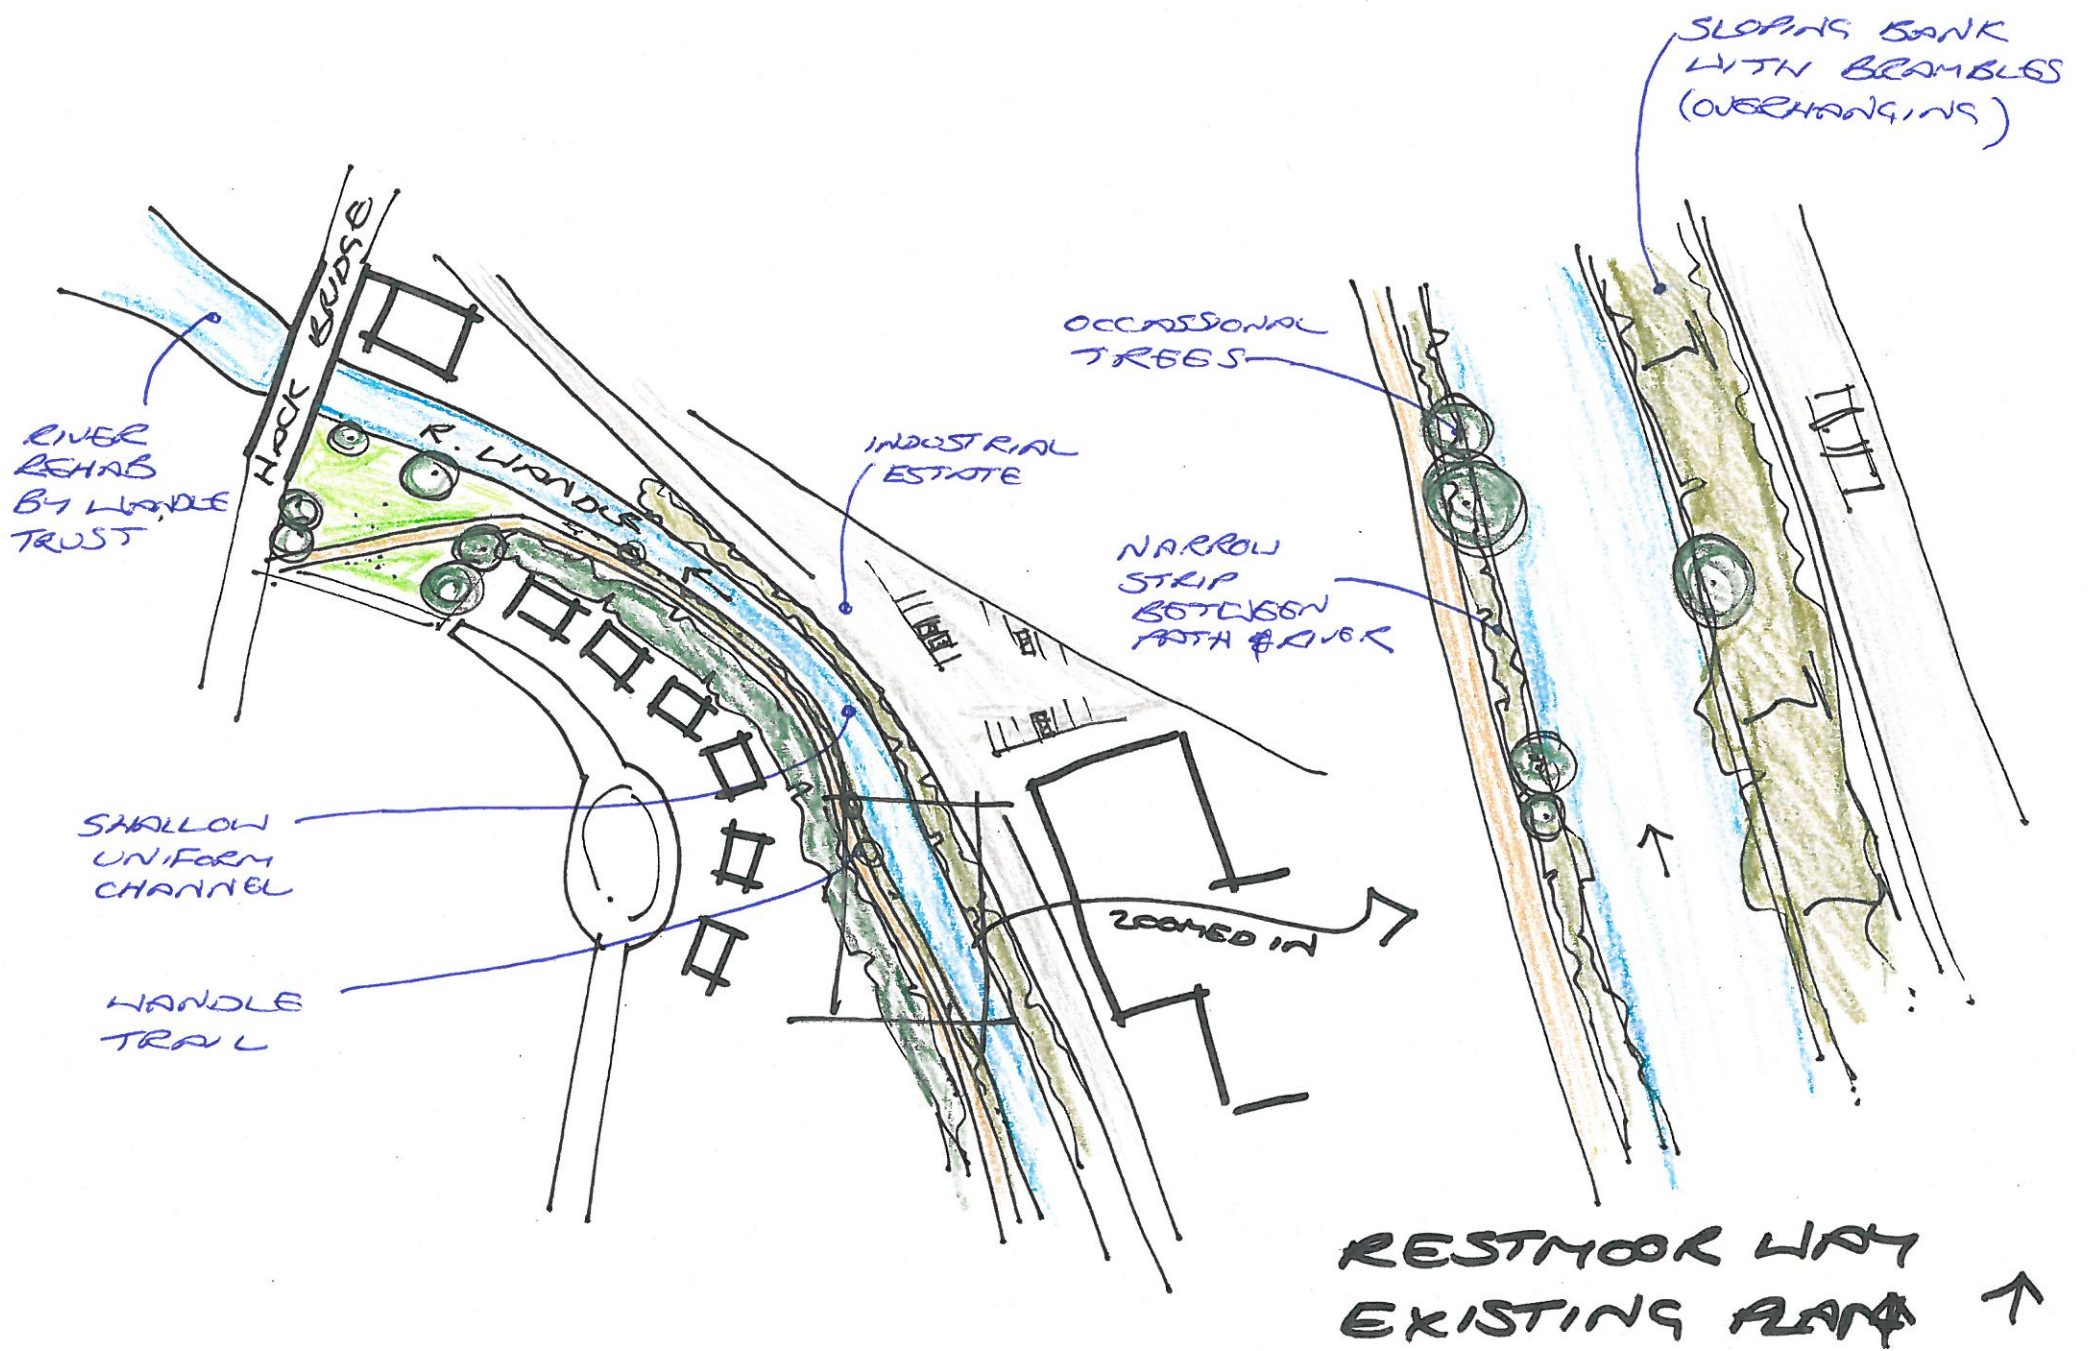
IN-CHANNEL
MODIFICATION
ALLOWS BANK
TO BE REPROFILED
(NICOSPAN)

IN-CHANNEL
PLANTING

EXISTING
VEGETATION
SELECTIVELY
CLEARED

GRAVEL ADDED
TO BED

IN-CHANNEL
MODIFICATION
(FAGGOT BUNDLES)

RETAIN
SOME
EXISTING
OVERHANGING
VEGETATION

LWM could be
added instead of
building out banks
in places
